ARBORICULTURAL ASSESSMENT & IMPACT REPORT

42A PARKGATE STREET
DUBLIN 8

Project No.	Project name	Date	Revision
TPAR002	Parkgate Street	27/10/23	-

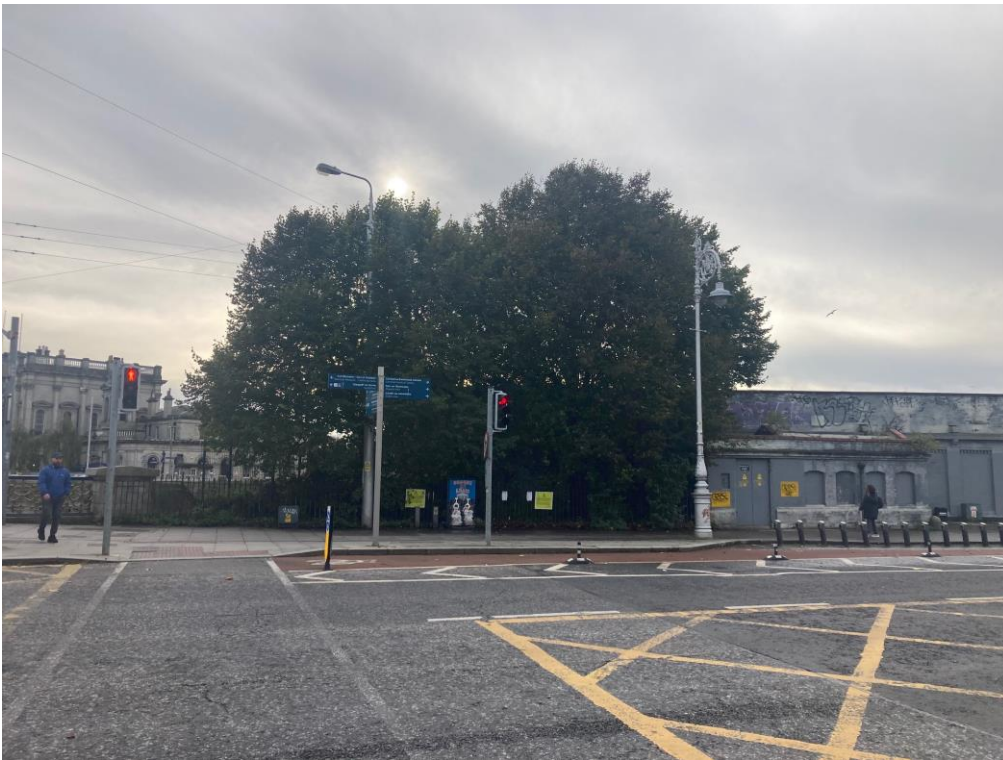
Image 2. View of trees from Parkgate Street

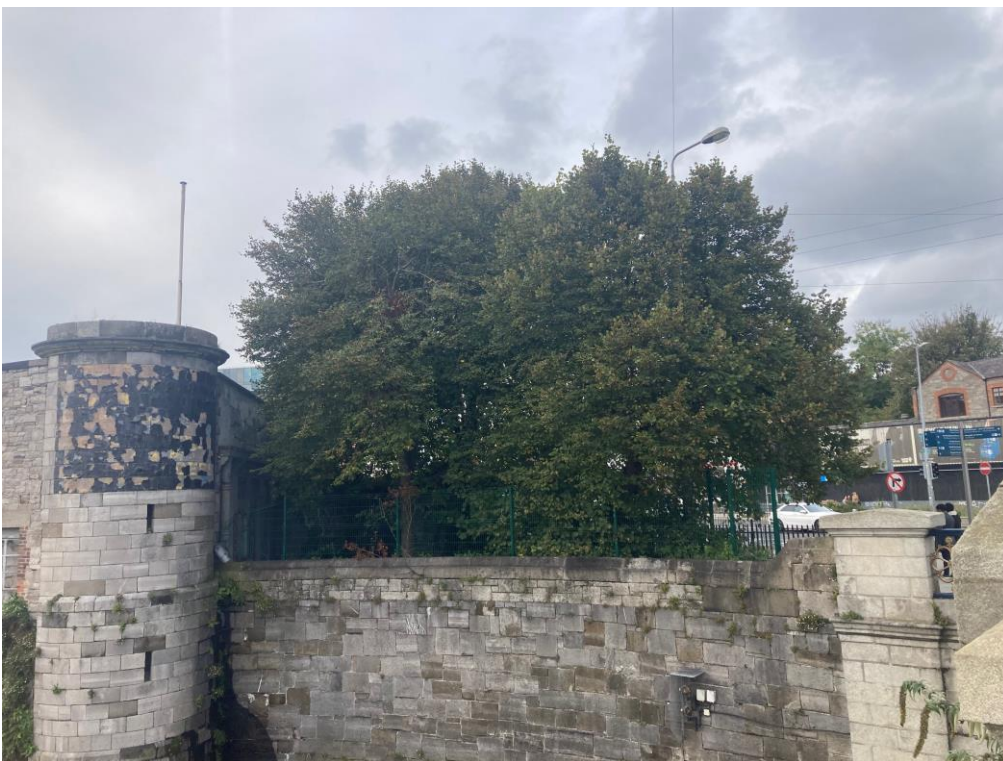
Image 3. View of trees from Seán Heuston bridge
